STRUCTURAL INTEGRITY RESERVE STUDY
FOR
SEA CHASE CONDOMINIUM
9577 GULF SHORE DRIVE
NAPLES, FLORIDA 34108

PREPARED FOR:

PREPARED BY: CARTER A. NELSON, R.S., E.I.T.
BRIAN J. ELLIOTT

SEPTEMBER 2024

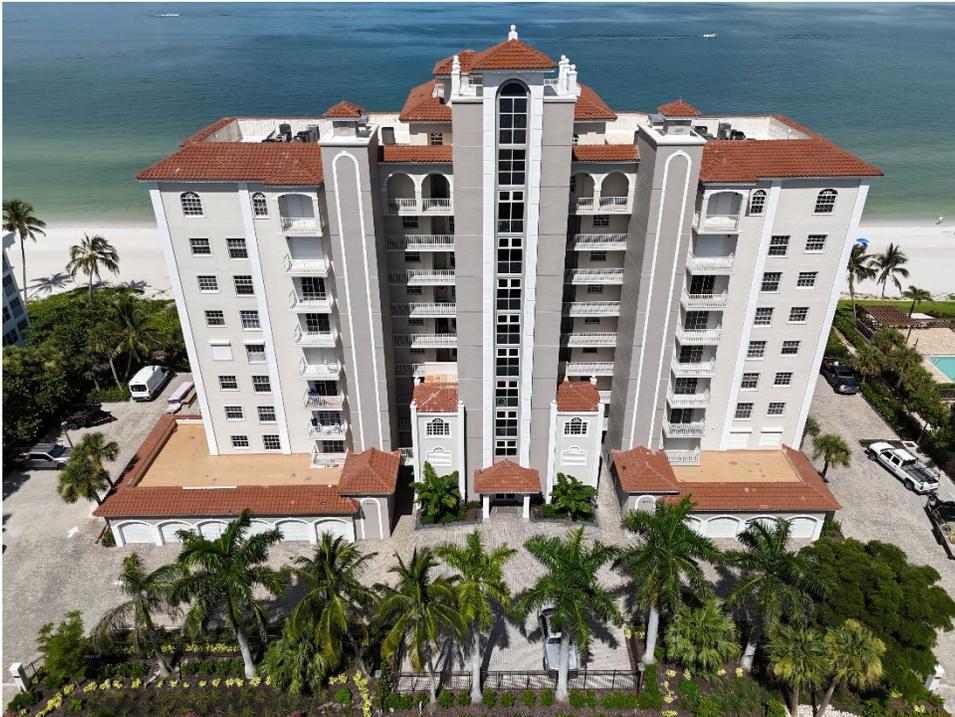
1. View of the east (front) elevation of the subject structure.

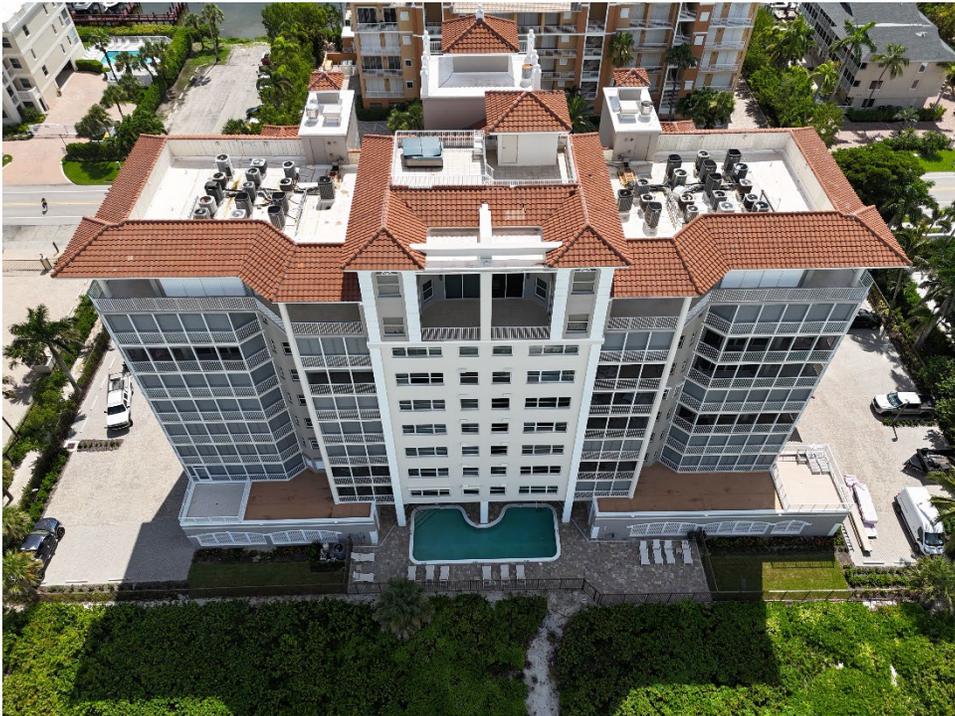
2. View of the roof and west elevation of the subject structure.

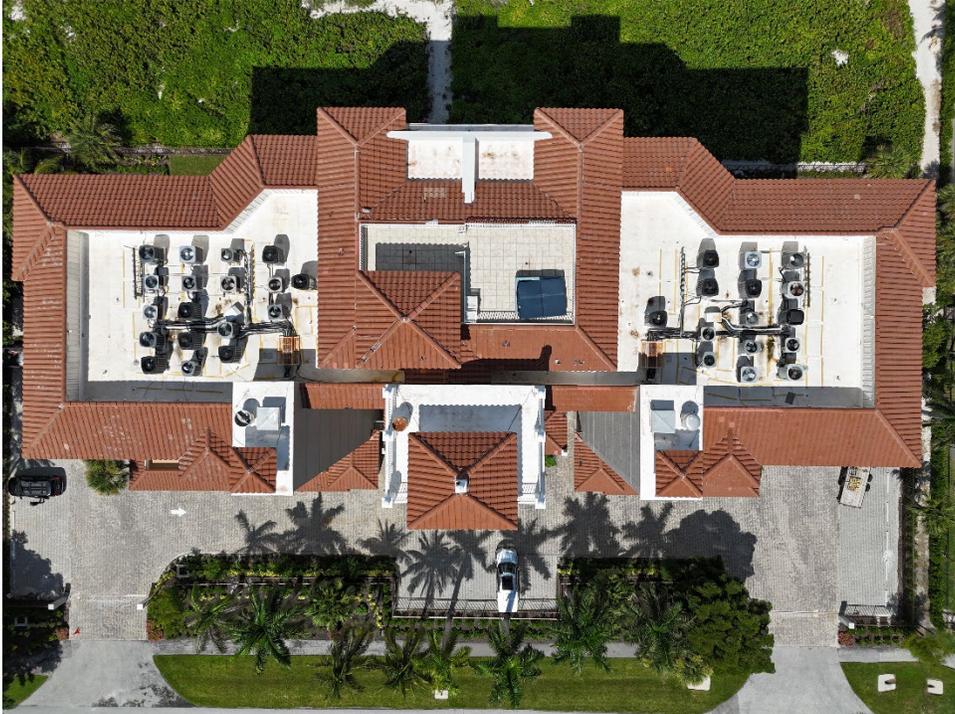
3. Overview of the roof system.

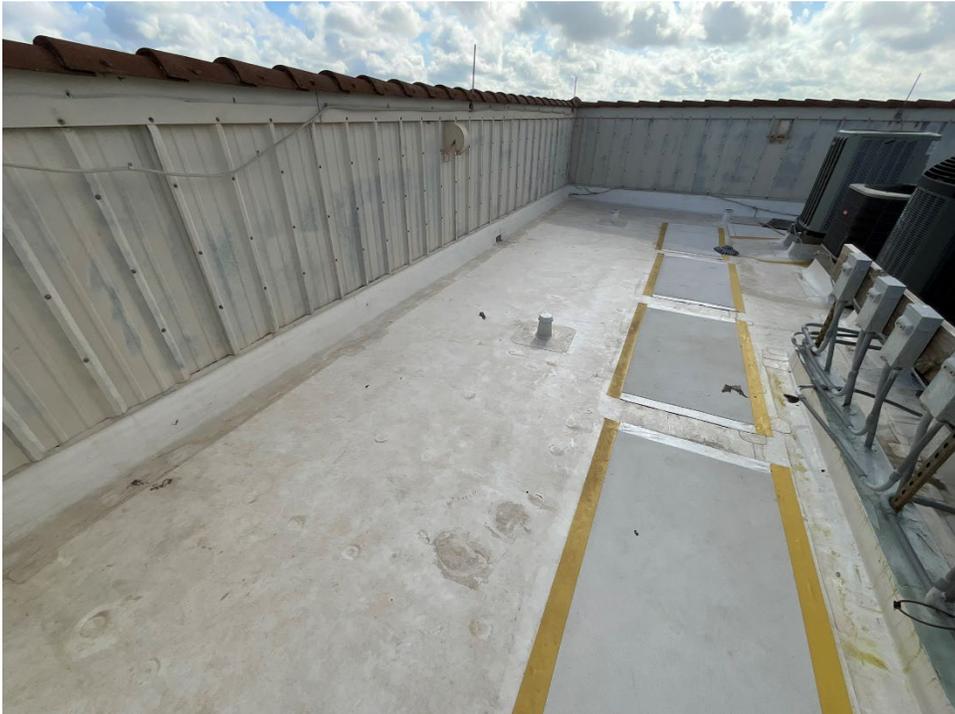
4. View of the Duro-last PVC roofing membrane installed in 2022.

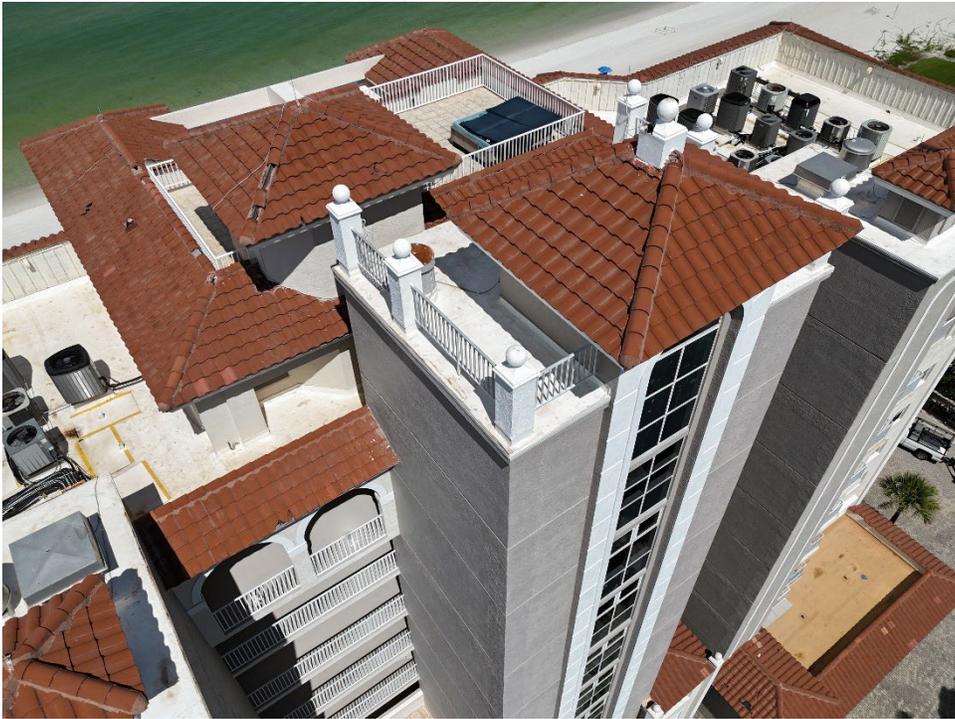
5. View of various missing, cracked, displaced, and/or repaired roof tiles.

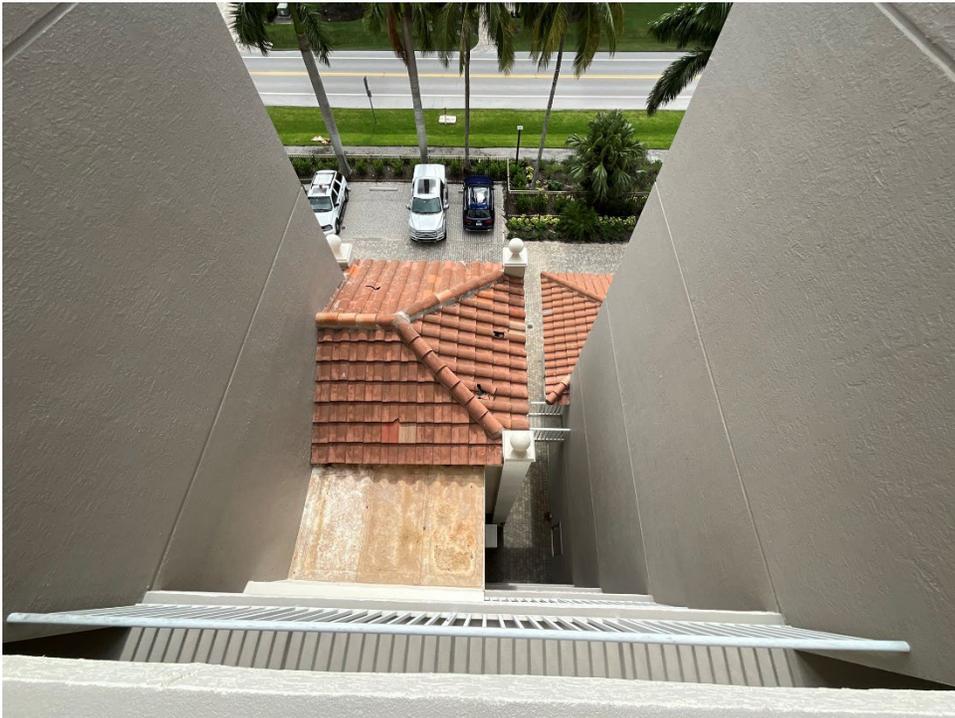
6. View of various missing, cracked, displaced, and/or repaired roof tiles.

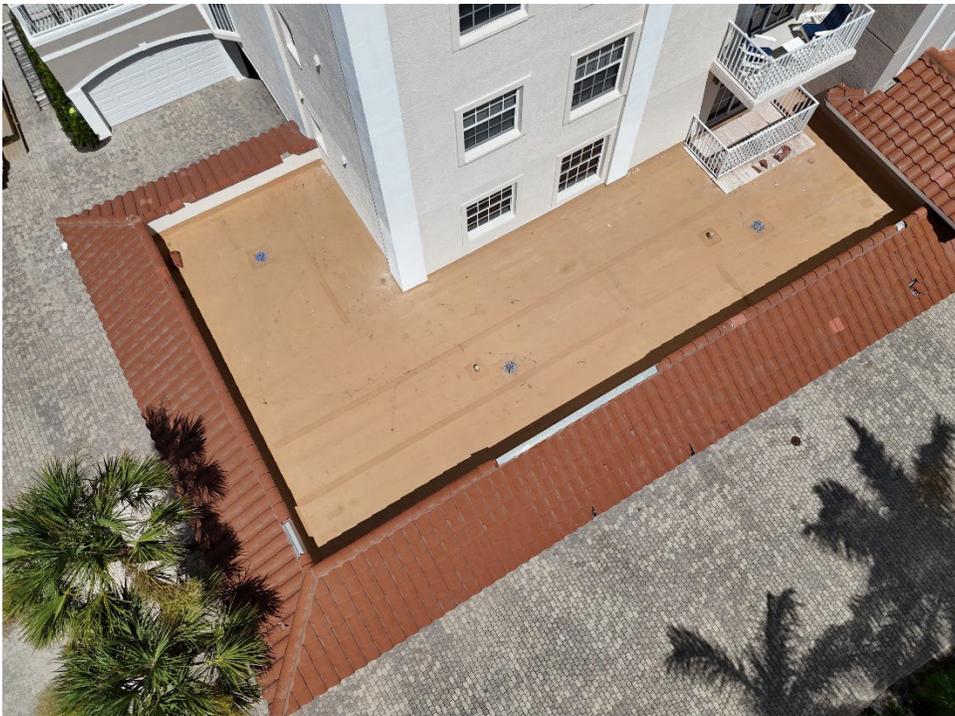
7. View of the Duro-last PVC roofing membrane installed above the garage in 2022.

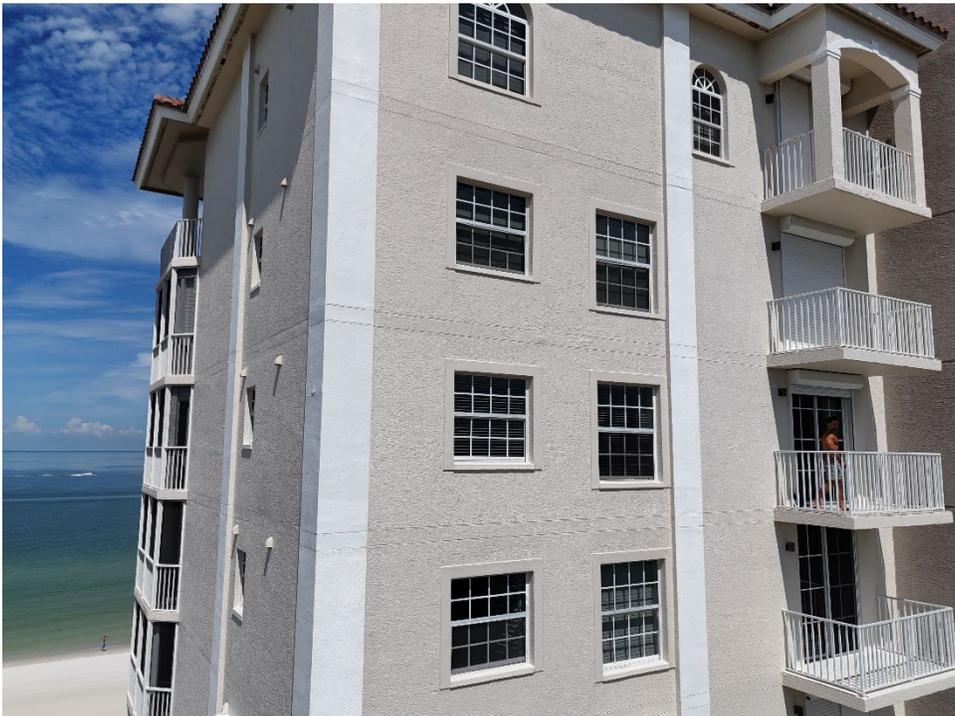
8. View of the exterior of the subject structure.

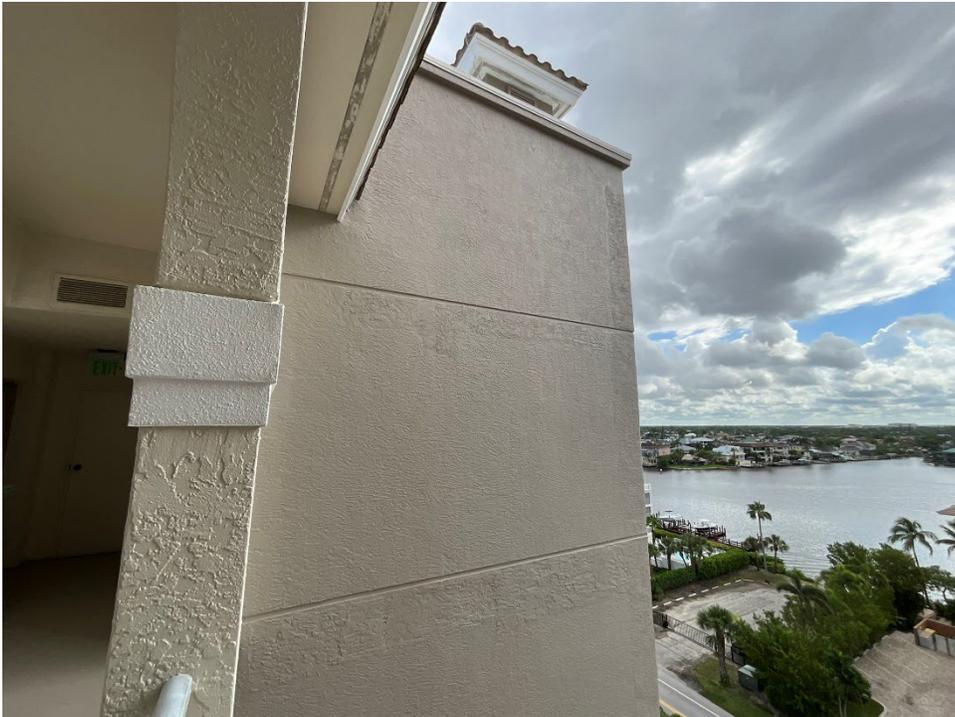
9. View of the apparent stucco and structural repairs in 2022/2023.

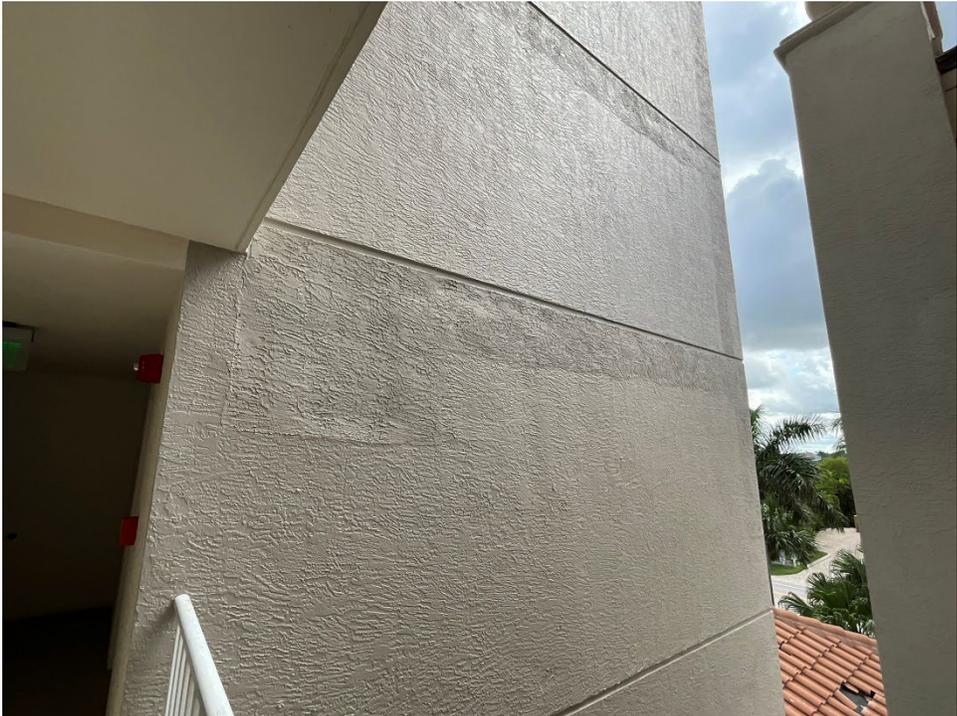
10. View of the apparent stucco and structural repairs in 2022/2023.

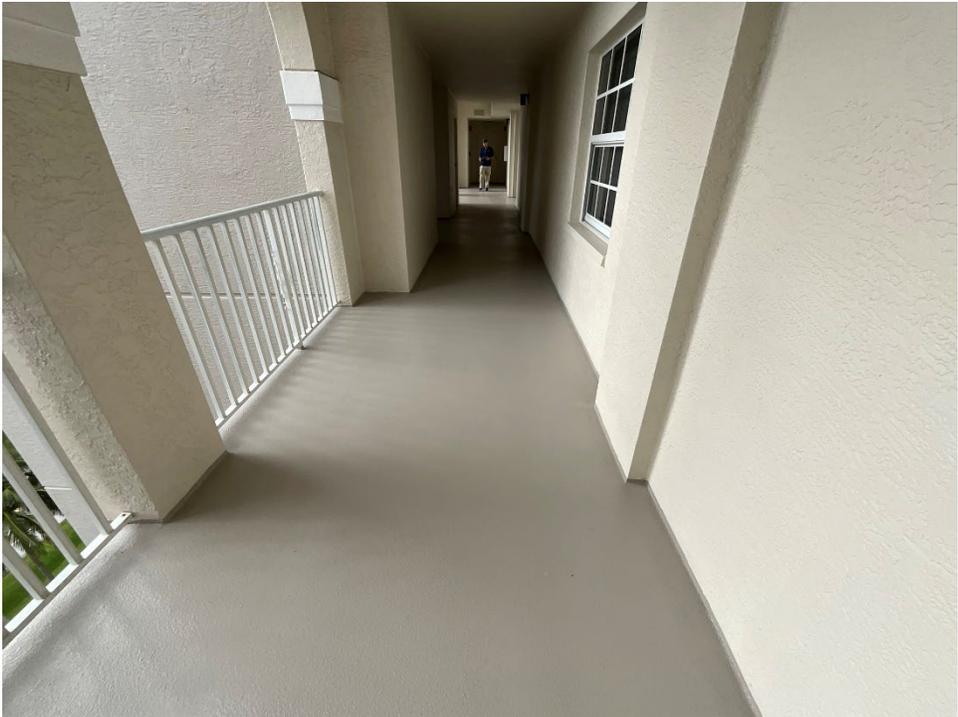
11. View of the exterior and breezeway floor painted in 2022/2023.

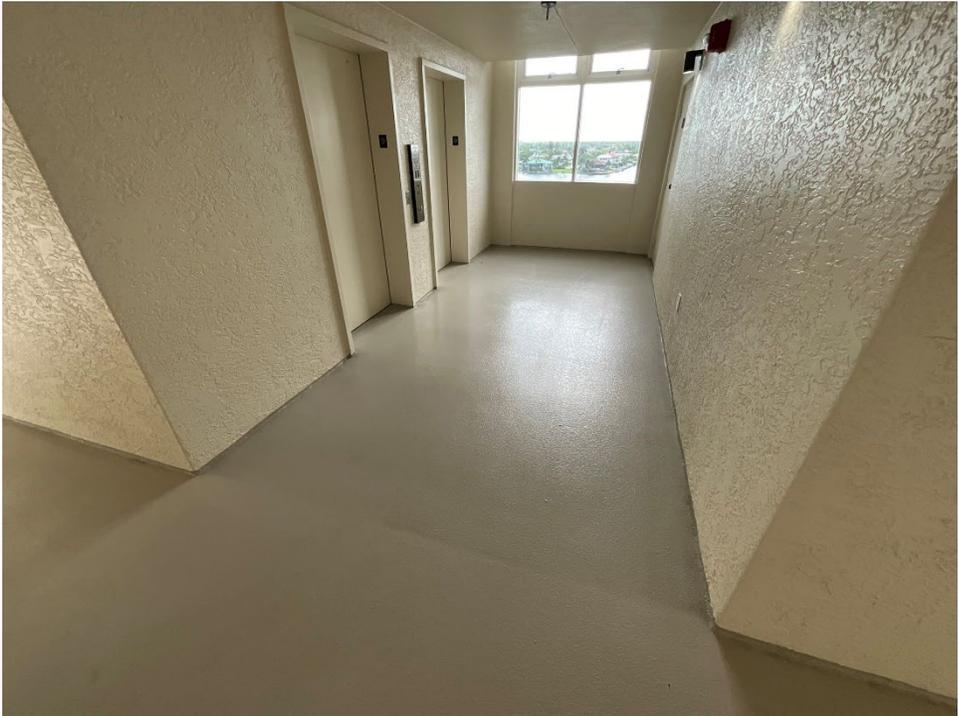
12. View of the exterior and breezeway floor painted in 2022/2023.

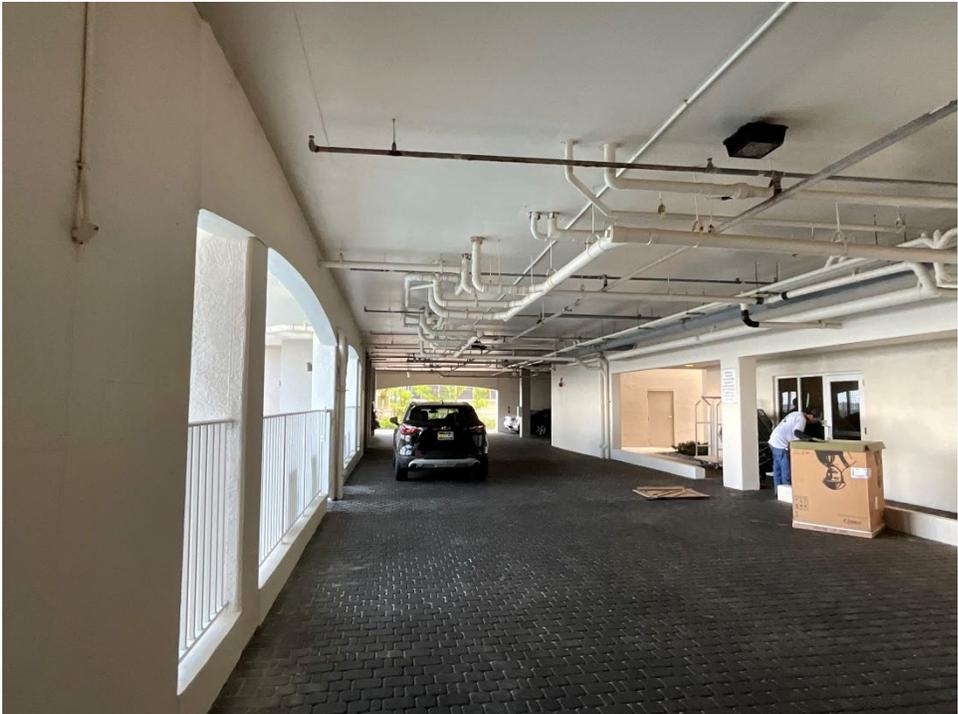
13. The garage walls, ceiling, columns, and plumbing pipes were apparently painted in 2022/2023.

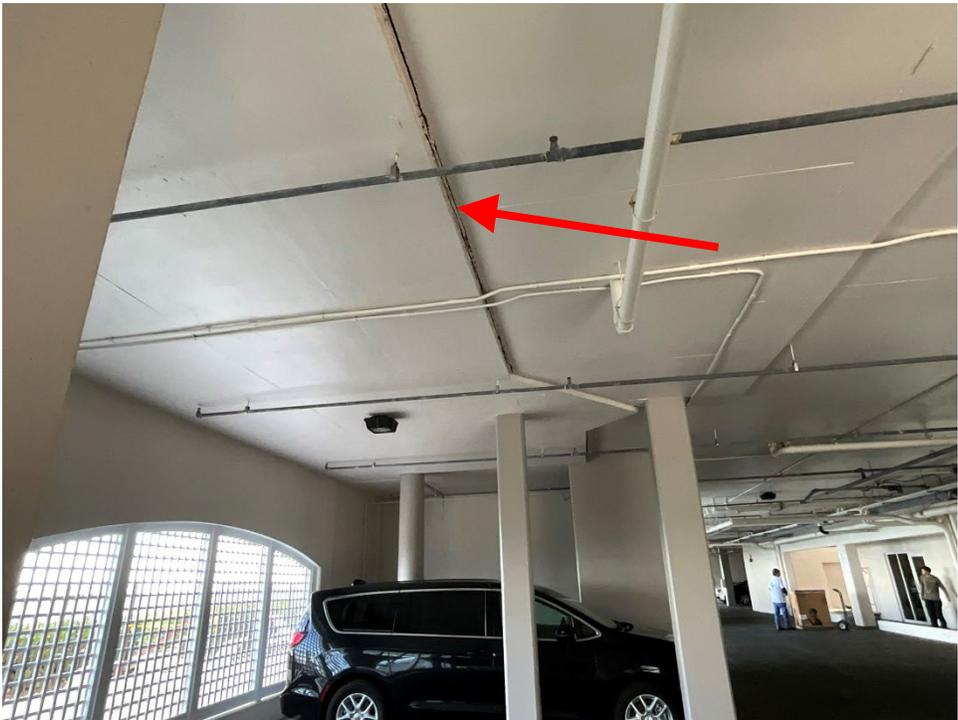
14. View of the expansion joint between the garage roof and primary structure.

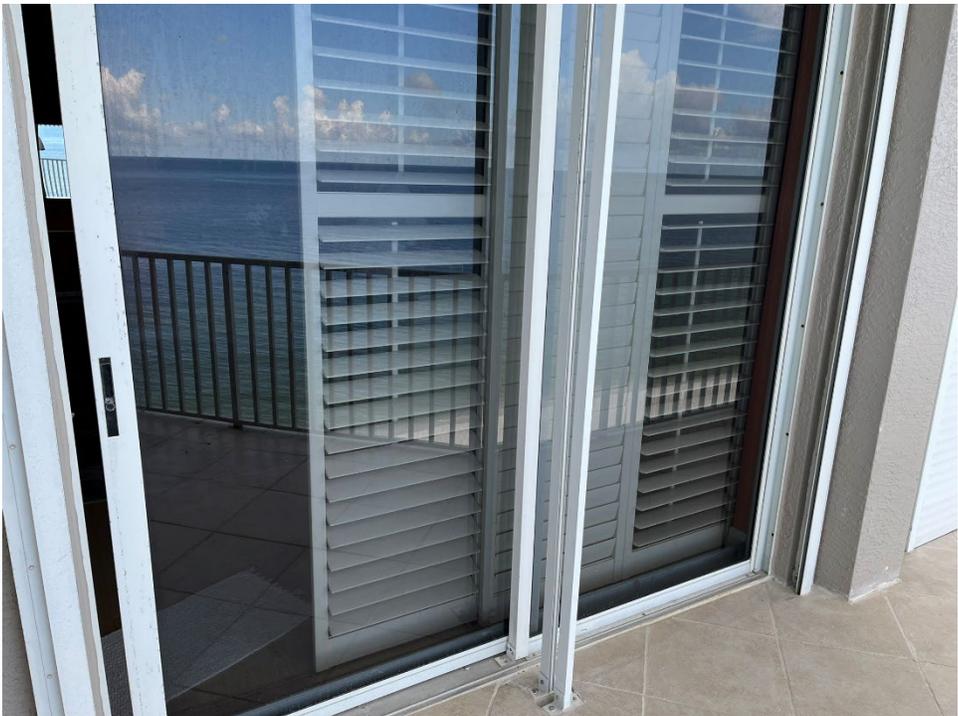
15. View of the typical slider doors to the lanai. The assessed doors were operational with no issues.

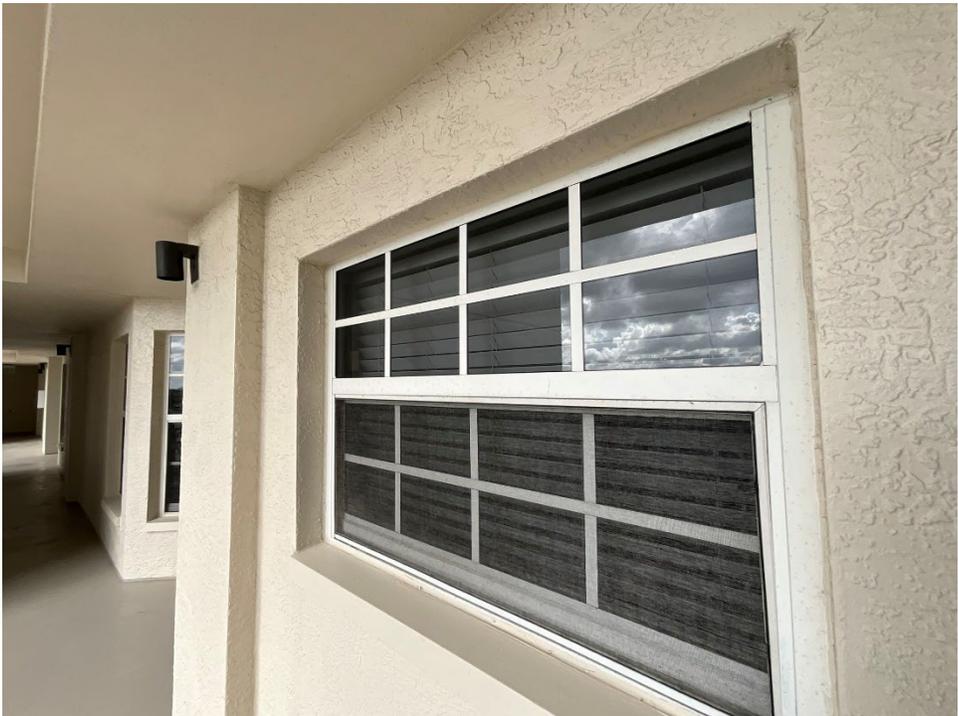
16. View of the typical windows along the breezeway. The assessed windows exhibited no issues.

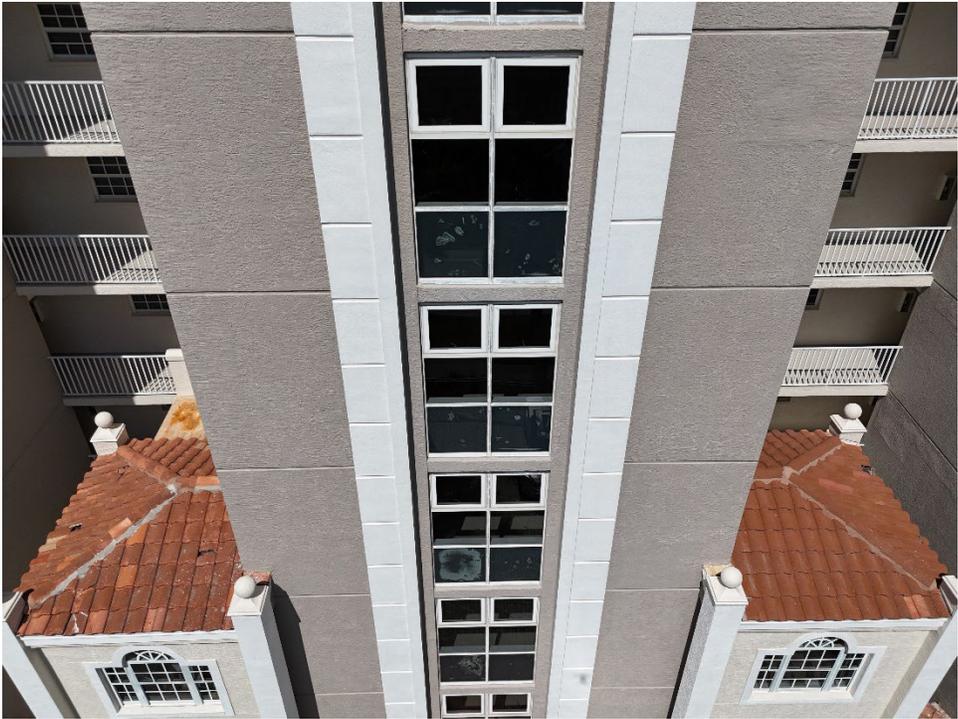
17. View of the windows in the breezeway/elevator area.

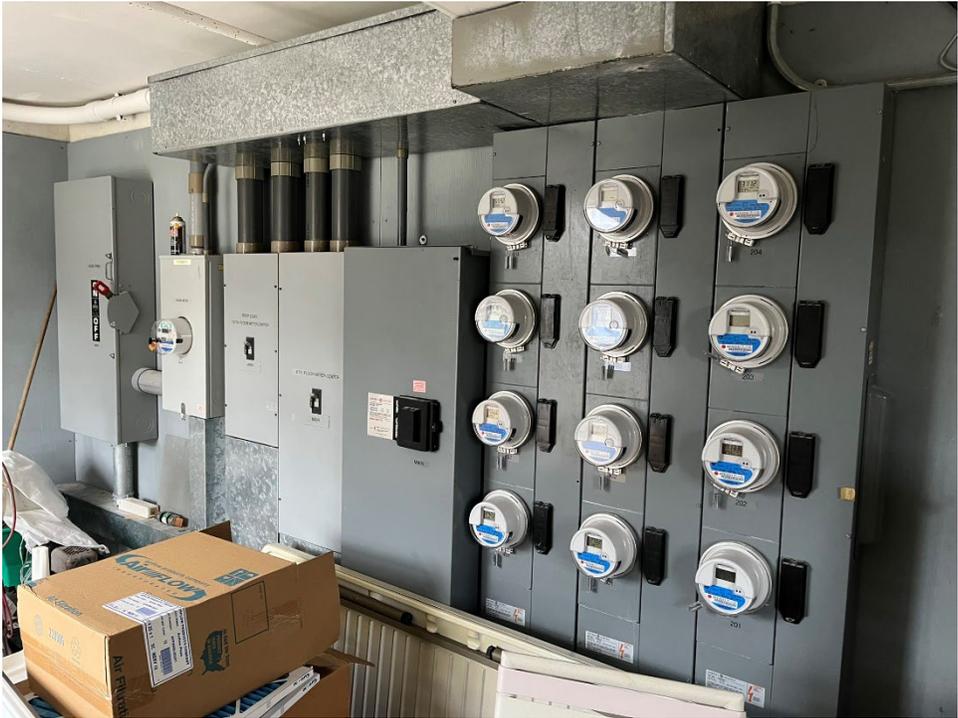
18. View of the electrical panels and switches.

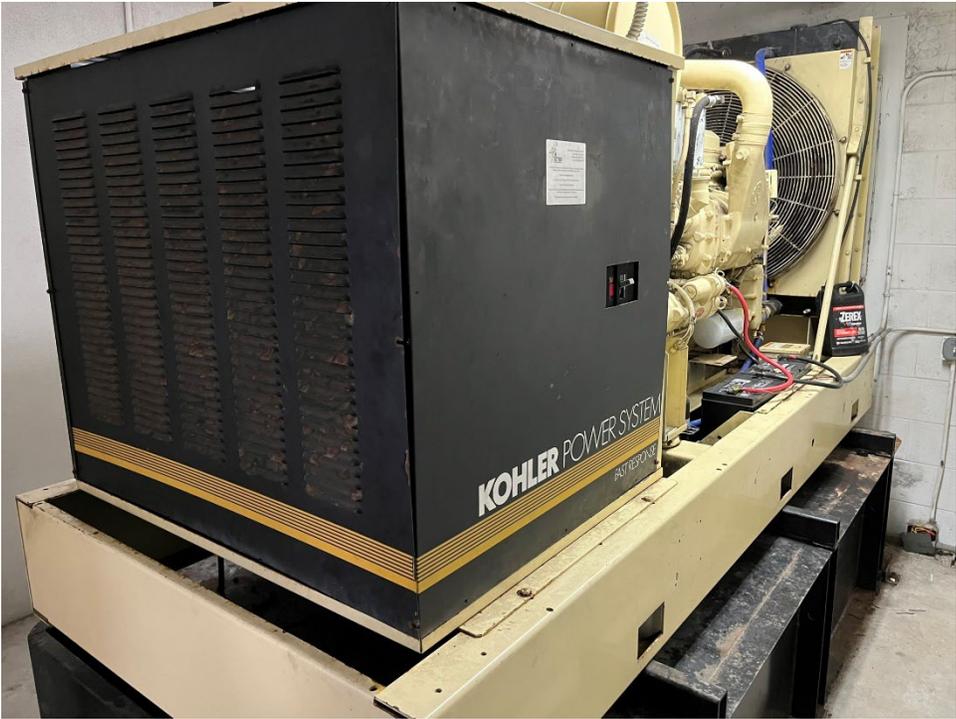
19. View of the backup generator.

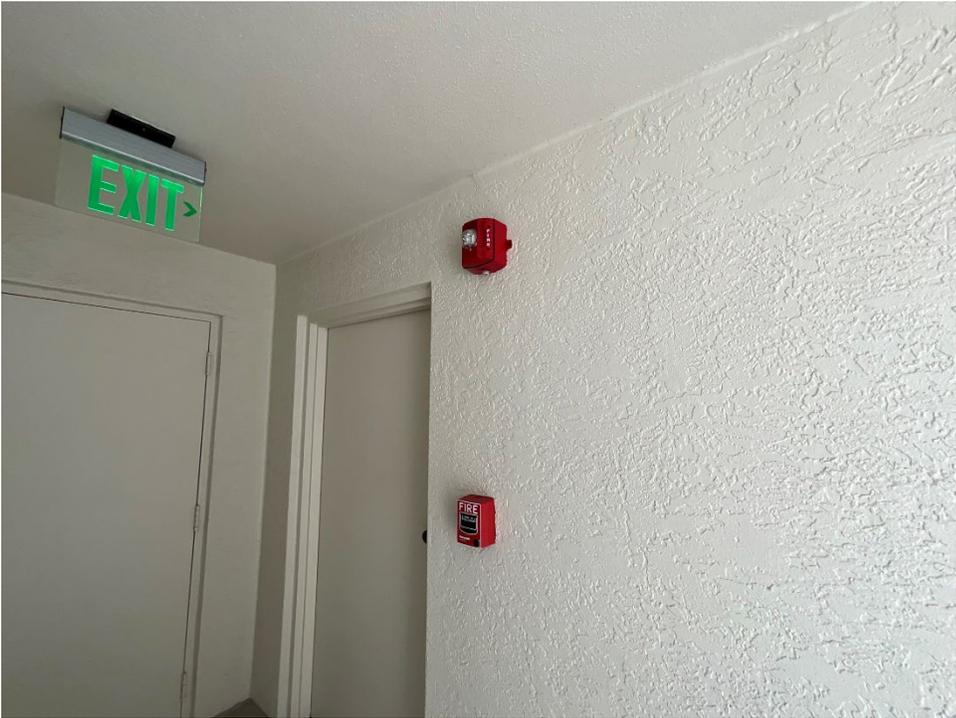
20. View of the typical life safety equipment.

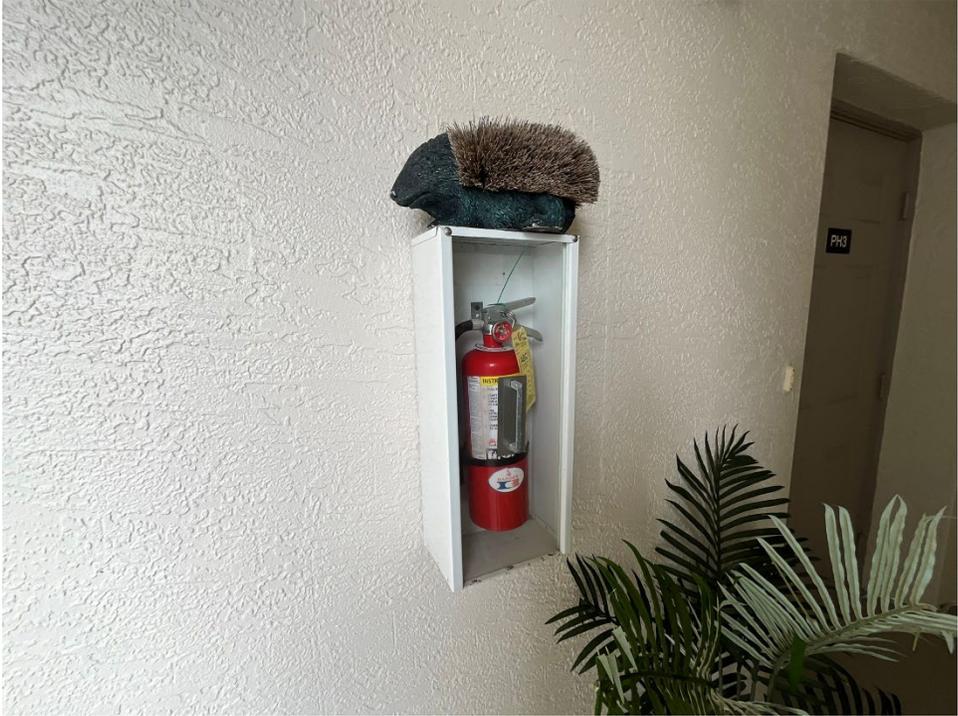
21. View of the typical life safety equipment.

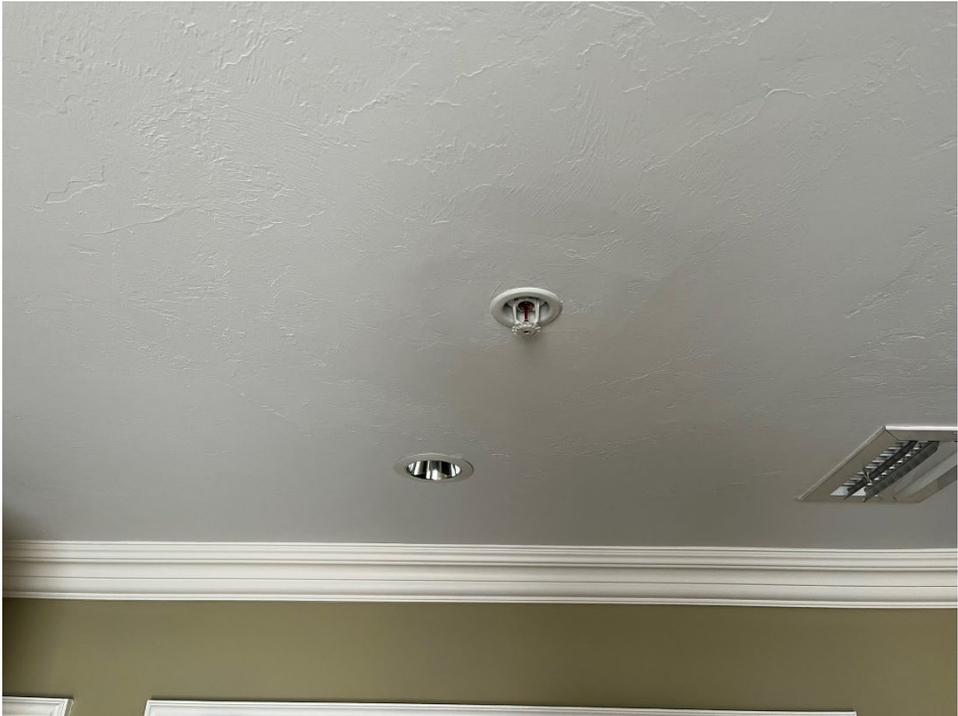
22. View of a typical fire sprinkler within the residential units.

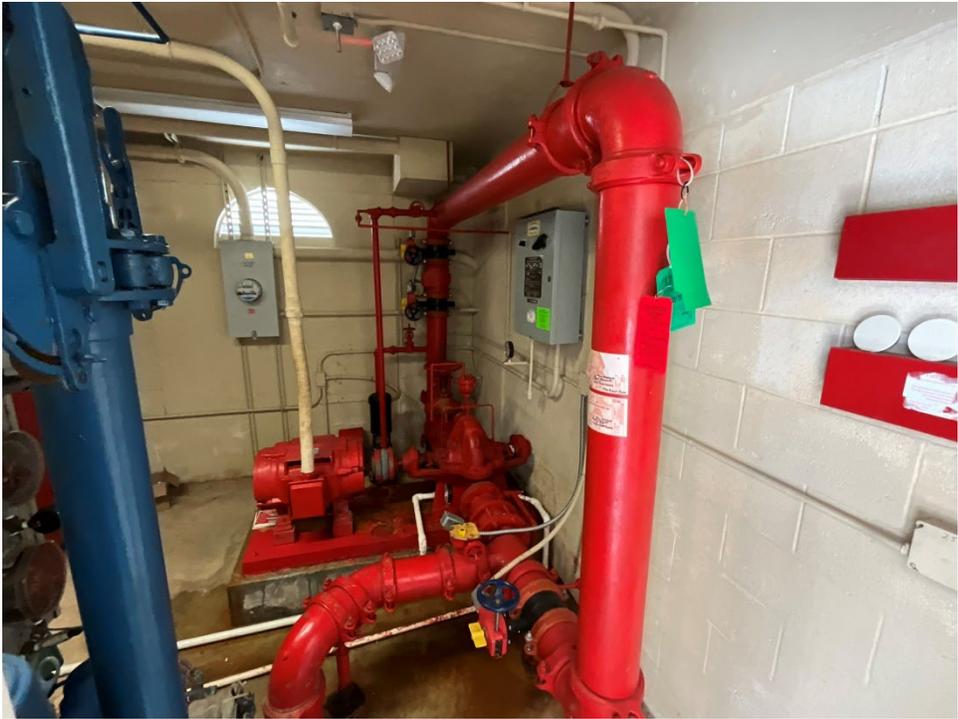
23. View of the fire pump.

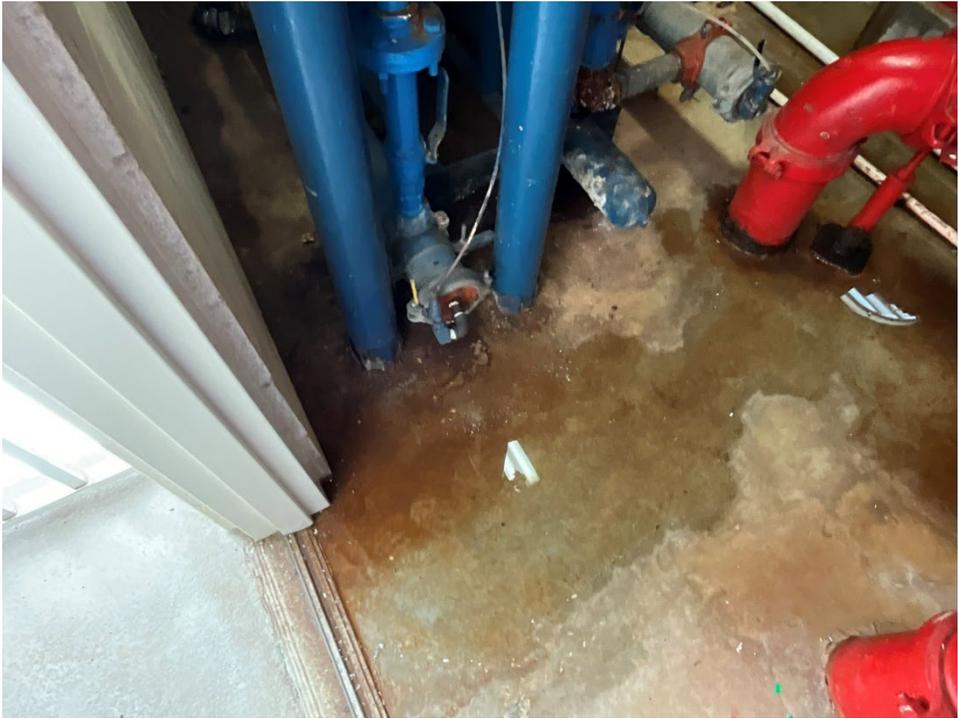
- An active leak within the pump room on the first floor. This leak has apparently been ongoing for some time based on the extent of corrosion on the fire pump main at the first-floor slab. There are immediate repair concerns of failed plumbing connections within the pump. Once the leak is repaired, a detailed inspection of the corrosion on the fire pump main shall be performed to determine whether the pump main needs replacement or repair.
- Many missing, cracked, and/or displaced roof tiles on various roof sections. Long-term exposure of the underlying waterproofing will accelerate the useful life of the tile roof covering. It is our understanding that the tile roofs are scheduled for replacement within the next year.

24. View of an active leak in the pump room.

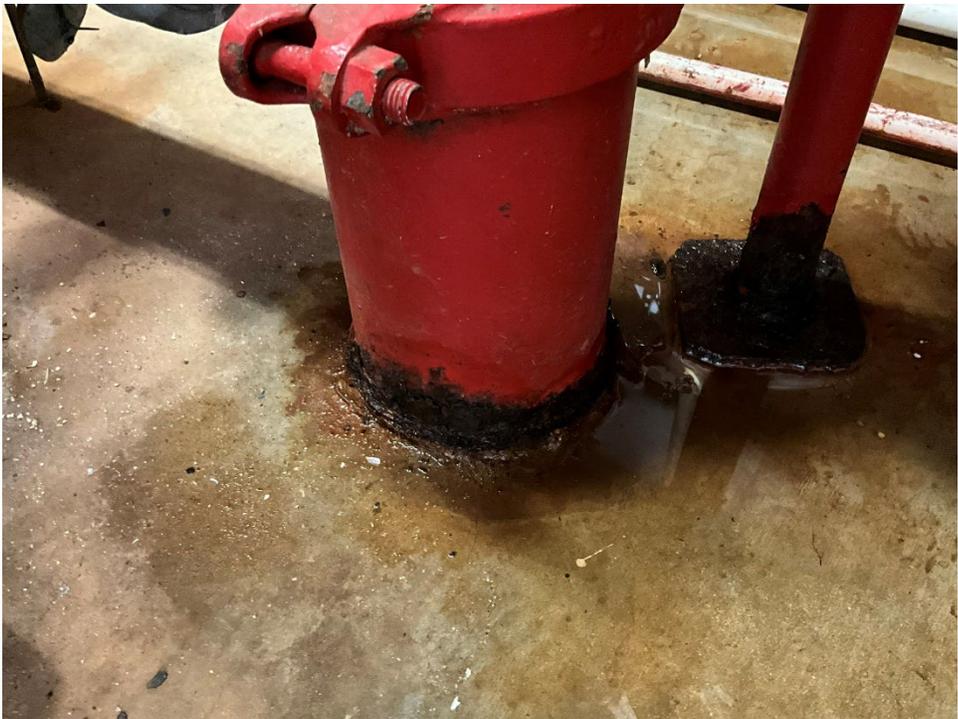
25. View of the significant corrosion on the fire pump main at the first-floor slab.

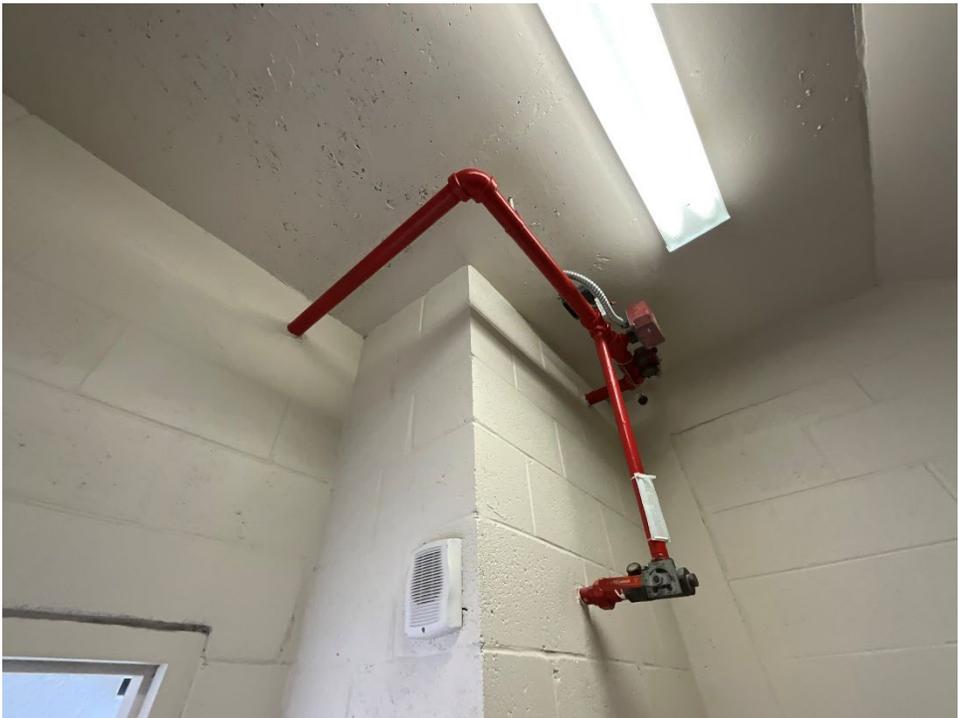
26. View of the CMU around the chase for the standpipe within the stairwell.

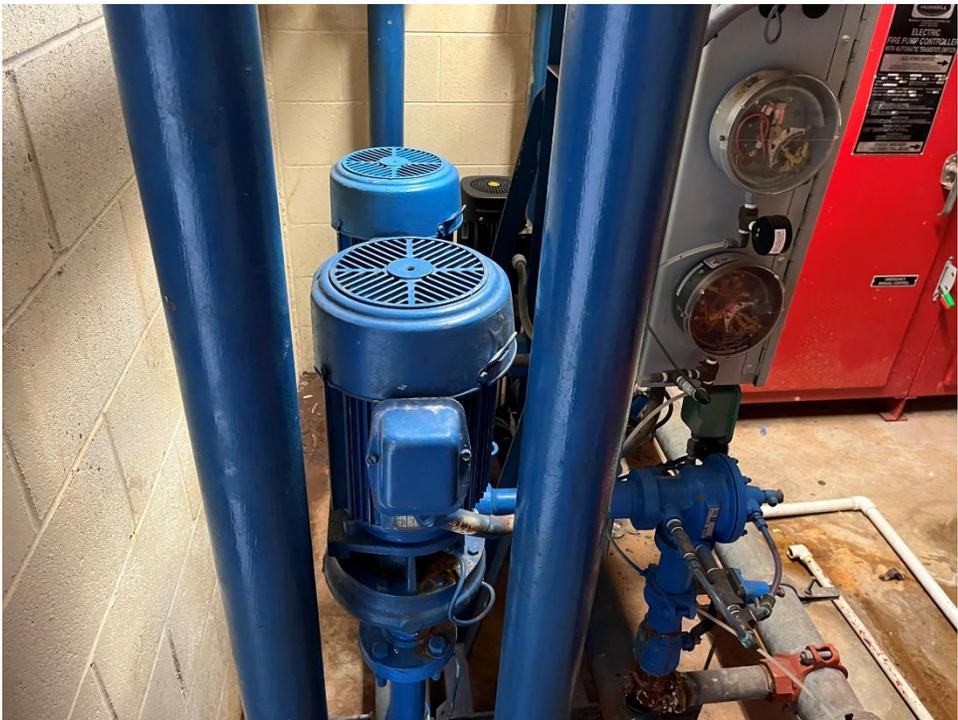
27. View of the domestic water pumps.
